# POST TENSIONING ANCHOR CABLES TO ENSURE FOUNDATION STABILITY OF AN ARCH-GRAVITY DAM

M van den Berg<sup>1</sup>, DG Cameron-Ellis<sup>2</sup>, and AL Parrock<sup>3</sup>

1. ARQ (Pty) Ltd, Pretoria, South Africa.
2. ARQ (Pty) Ltd, Pretoria, South Africa.
3. ARQ (Pty) Ltd, Pretoria, South Africa.

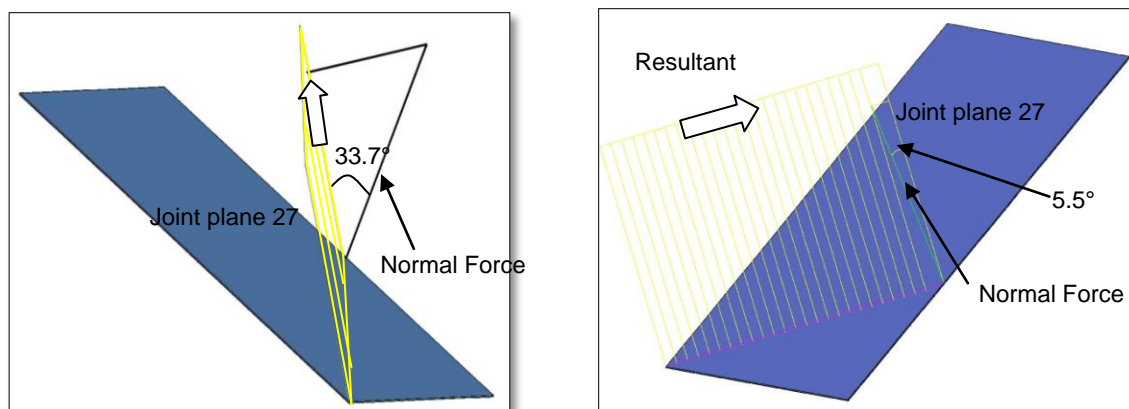
Figure 6: Projected normal force on joint plane 27 in a) upstream-downstream, b) diagonal direction

The proposed cable anchors are primarily orientated in a direction to increase the normal force and subsequently the friction on the identified critical planes. This necessitated a concrete anchor block at ground level from where the anchors could be stressed, accepting an anchorage at a safe distance below the potential sliding plane. The resultant force on each sliding plane is the critical force, thus the foundation must be stable on the subsequent resultant plane of the two identified joint planes. Accordingly the anchors were designed to increase the normal force on the resultant planes. Analysis indicated that the resultant force on joint plane 31 was greater than the resultant force on joint plane 27. Subsequently the anchor cables were designed normal to joint plane 31 and the projected normal force was used in analysis at joint plane 27 as indicated in Figure 6.

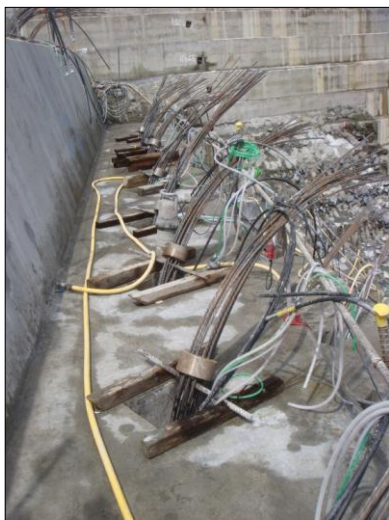
Figure 9: Anchor cables installed

The cable anchors comprise post-tensioned tendons which are installed in drilled holes and the entire bond length (8m) is located in competent rock below the failure planes. The anchor force is transferred to the rock by the bond between the grout and the rock.

The cable anchors remained unbonded in the free stressing length allowing the anchor to be checked and re-tensioned at any time. To prevent corrosion, protection in the form of HDPE sheaths around the tendons was provided in the free length of each strand. An outer HDPE sheathing was furthermore included in the system to prevent any possible corrosion attack. In the anchorage zone this was configured to allow bond forces to be transferred to the surrounding rock.

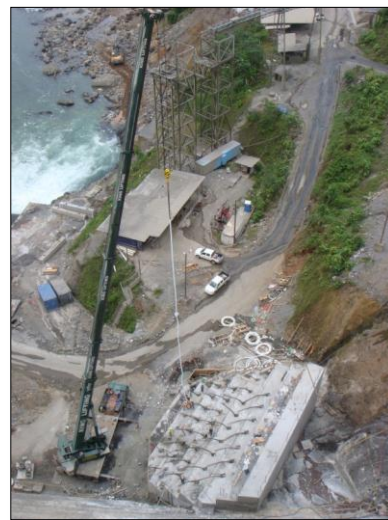
Figure 10: Installing anchor cables

Initially a small load was applied to each tendon to prevent entanglement of the tendons, after which the load was increased to a preload of 5% of the ultimate load. The load was then increased gradually to the specified testing load (80% of ultimate). All tendons were checked for excessive sequential losses in the same order as initially stressed after lock-off. When the lift-off load was found to be less than 68% of the ultimate load, the tendons were re-stressed to 73.1% of the ultimate load.
